Cider Press Restoration Project (November – December 2016)

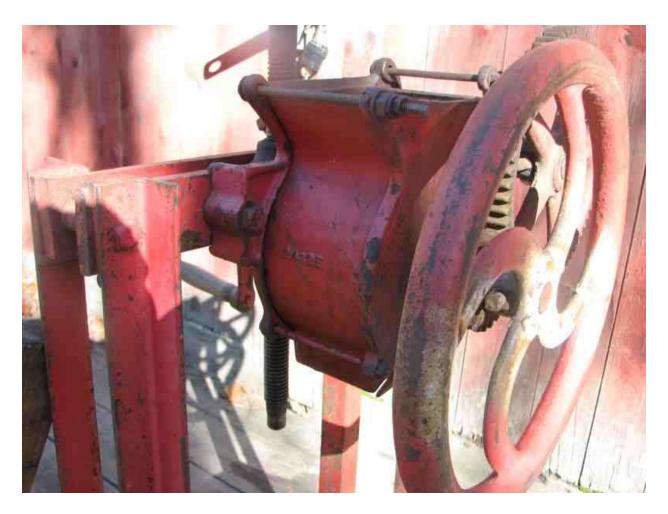
It seemed to me that the cider press was in pretty bad shape. The paint was peeling and chipped; rust was showing through everywhere; the press was disgustingly dirty. So I decided that before trying to haul it out to Ann Arbor, I would first have to clean it up and repaint it.

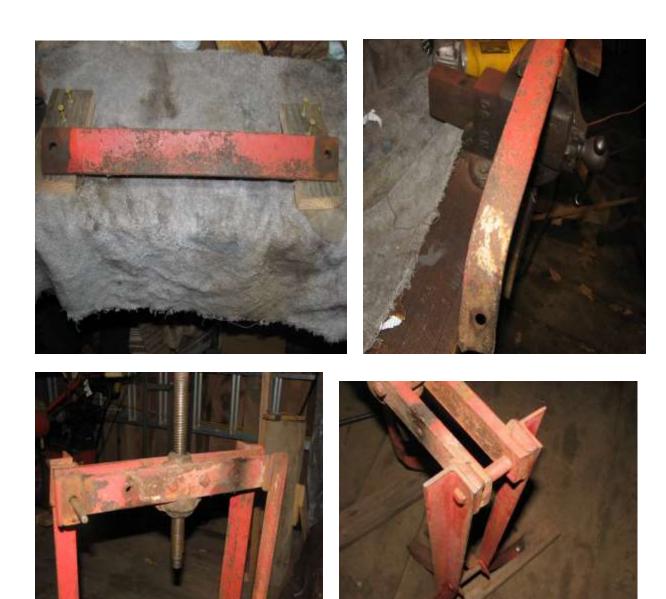
Rust and peeling paint everywhere! A total wreck. So I got out my angle grinder with a wirebrush installed. I started to grind off the old paint and the rust. Here is a typical before-and-after comparison:

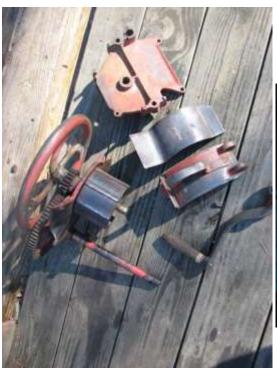
I also dismantled the bin into which the apples are placed to be ground up. This was a complicated job since some of the gears were firmly rusted onto their shafts. I had to get a gear puller to get the gears off the shafts. The rest came apart pretty easily:

The bolts were rusted and bent. They would have to be replaced. After wirebrushing all these pieces I primed them with grey primer and then painted them with Rustoleum Regal Red paint. Here is an example of a part first wirebrushed, then primed, and then painted:

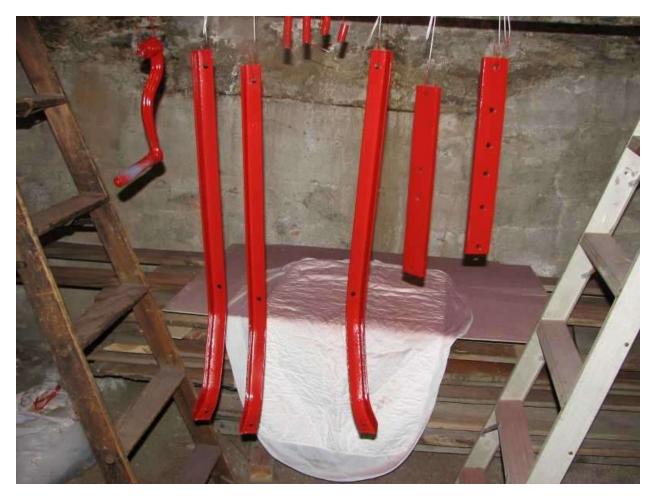
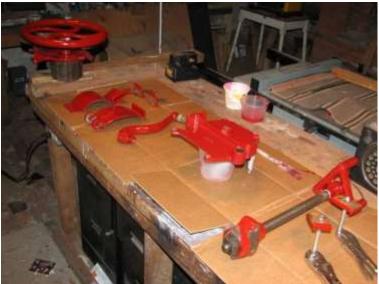
I then proceeded to prime and paint the rest of the pieces. It was very cold in the barn; the paint was not drying properly. So I moved the painting operation into the furnace room in the cellar. Here is a picture showing some parts drying down there. And another showing pieces on the workbench:

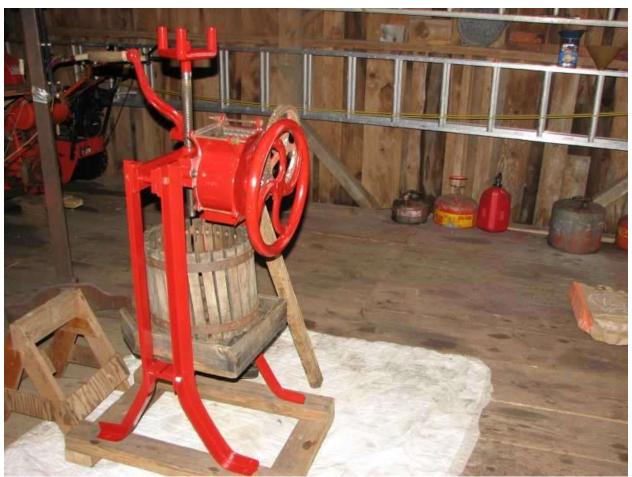
Once the painting was finished, it was time to try to put it all back together. I did that back in the barn using a new set of bolts that I got at Fastenal in Greenfield:

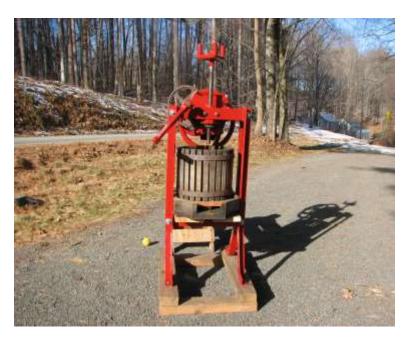
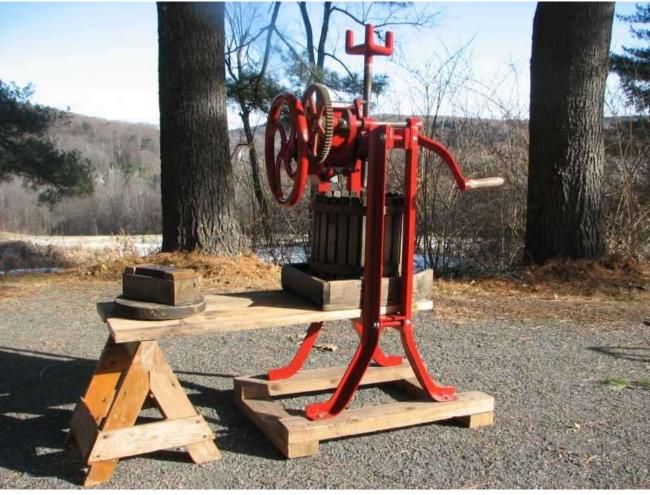
And then, when the press had been completely reconstructed, I took it outside to get some nice pictures on a bright sunny day:

The cider press restored and ready to be transported to Ann Arbor.
